Re: NOV 92-40-1-1, SBC-3 Monitor Well. Bear Canyon Mine, Co-Op
Mining Company, ACT/015/025, Emery County, Utah

Proposal for Repair of SBC-3 Monitor Well.

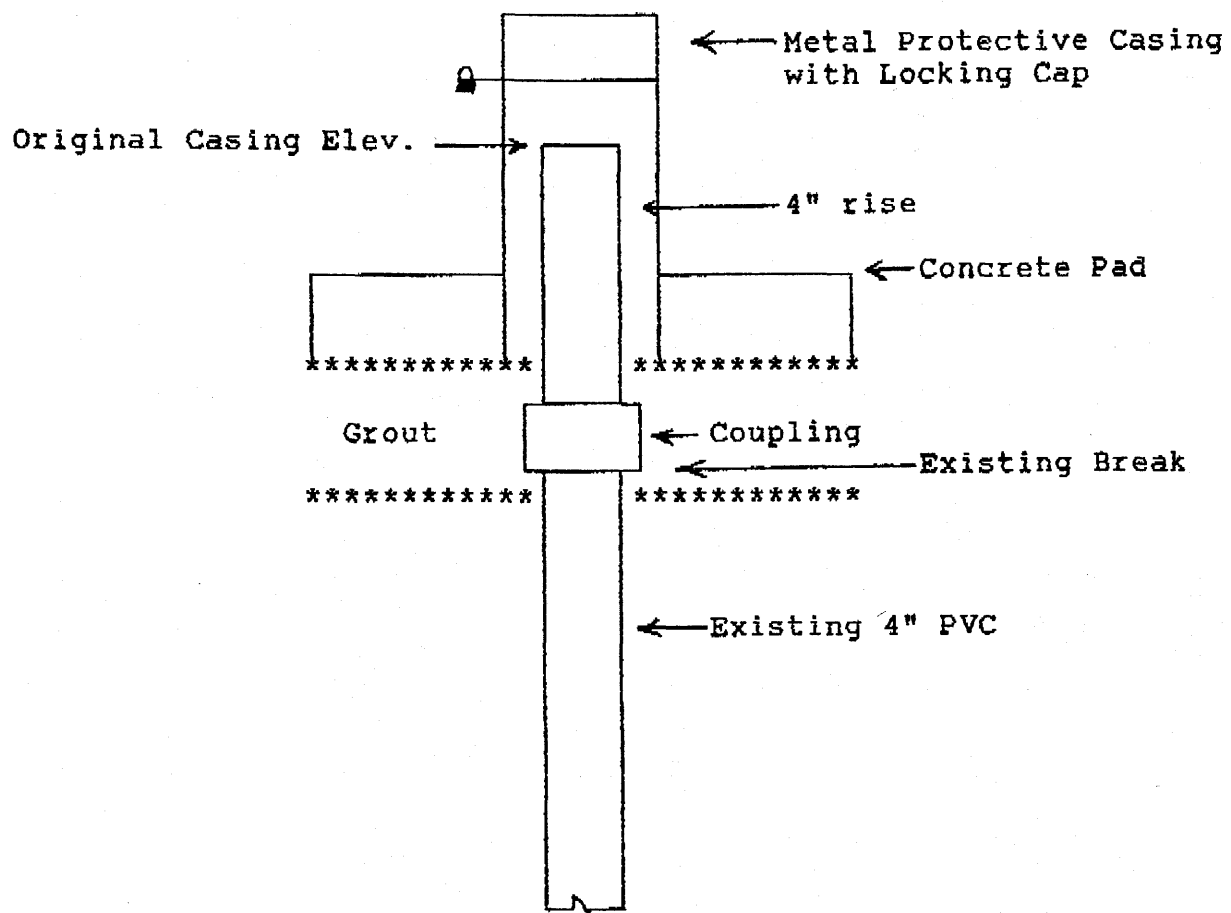
Figure A.

The repair of SBC-3 will be completed by licensed Well Driller Dutch Zimmerman. The ground will be excavated to about 8" below the damage in the well casing. The casing will then be cut below the level of the damage.

A coupling will be placed at the new top of the casing, and a 4" PVC rise will be placed above the coupling to reestablish the well elevation. Grout will then be placed around the well, covering the coupling.

A square, metal protective casing will then be placed over the top of the well with a locking cap to protect the well. A concrete pad will then be placed around the well. Figure A shows a sketch of the proposed work. The original hole completion was 46 feet.
